# Access Compliance Report Public Rights-of-Way (Curb Ramps)

Main Street: OAK\_KNOLL\_DR Cross Street: ARGYLE\_DR Location: NW

ADA ID: RPAT211206132519 Ramp Type: Type 1 - Perpendicular Diagonal Initial Pass/Fail: Pass Overall Compliance: No Severity Score: 21

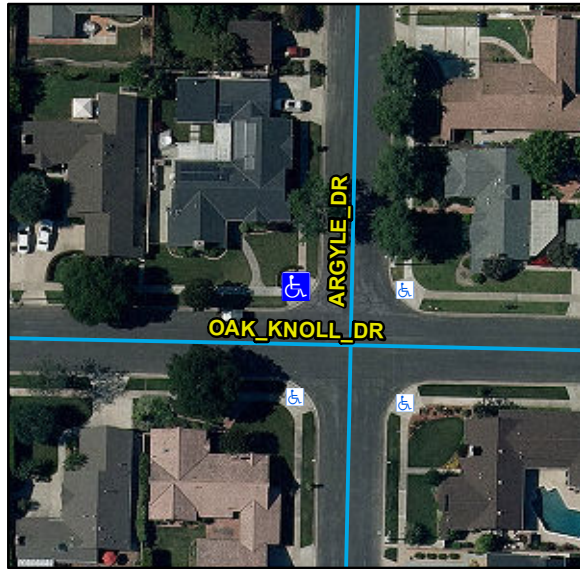
| Compliance | Description | Data | Compliance | Description | Data |
|---|---|---|---|---|---|
| No | Landing Run Slope (%) | 2.3 | N/A | Flare Traversable RT | No |
| Yes | Landing Cross Slope (%) | 0.6 | No | DWS Provided | No |
| Yes | Gutter Ponding | No | No | Curb Slope | 8.8 |
| No | Gutter Run Slope (%) | 6.1 | | Road Cross Slope (%) | 5.5 |

Remove & Replace Curb Ramp With Two New Directional Ramps or Equivalent. Remove & Replace Gutter.
