# Access Compliance Report Public Rights-of-Way (Curb Ramps)

Main Street: ARGYLE\_DR Cross Street: OAK\_KNOLL\_DR Location: SW

ADA ID: RPAT211206132807 Ramp Type: Type 1 - Perpendicular Diagonal Initial Pass/Fail: Pass Overall Compliance: No Severity Score: 20

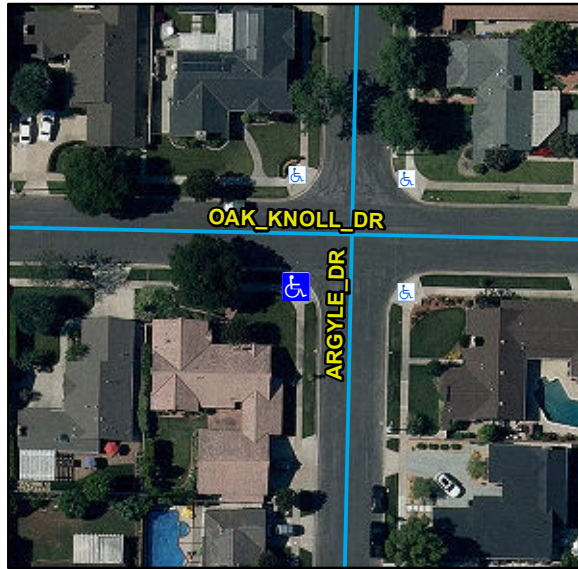
| Compliance | Description | Data | Compliance | Description | Data |
|---|---|---|---|---|---|
| No | Landing Run Slope (%) | 3.7 | N/A | Flare Traversable RT | No |
| Yes | Landing Cross Slope (%) | 1.1 | No | DWS Provided | No |
| No | Gutter Run Slope (%) | 6.2 | | Road Cross Slope (%) | 4.4 |

Remove & Replace Curb Ramp With Two New Directional Ramps or Equivalent. Remove & Replace Gutter.

R204.3, R304.2.1, R304.2.2-Perp, R304.3.2-Para, R305, R304.5.4, STD 1115
