# Access Compliance Report Public Rights-of-Way (Curb Ramps)

| Main Street: FOSTER_RD | | Cross Street: OAK_KNOLL_DR | | Location: | SW |
| ADA ID: RPAT211206133634 | Ramp Type:Type 1 - Perpendicular Diagonal Initial Pass/Fail: Fail | | Overall Compliance: No | Severity Score: | 30 |

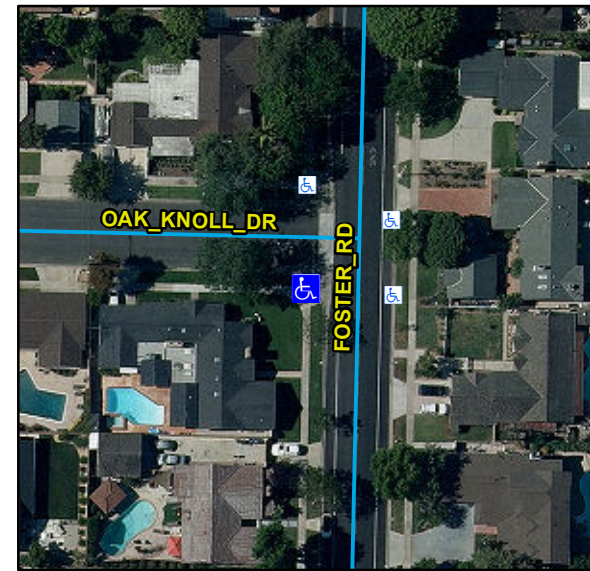
| Compliance | Description | Data | Compliance | Description | Data |
|---|---|---|---|---|---|
| No | Ramp Run Slope (%) | 8.4 | N/A | Flare Slope LT (%) | N/A |
| No | Overall Surface Condition: | Poor | No | Perp Joint Present | No |

**Remove & Replace Curb Ramp With Two New Directional Ramps or Equivalent.**

**R204.3, R304.2.2, R302.7, STD 1115**
