# Access Compliance Report Public Rights-of-Way (Curb Ramps)

Main Street: OAK\_KNOLL\_DR Cross Street: FOSTER\_RD Location: NW

ADA ID: RPAT211206133841 Ramp Type: Type 1 - Perpendicular Diagonal Initial Pass/Fail: Pass Overall Compliance: No Severity Score: 16

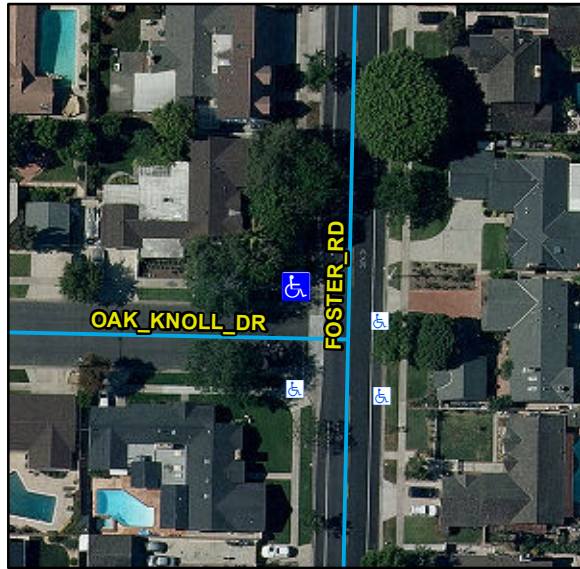
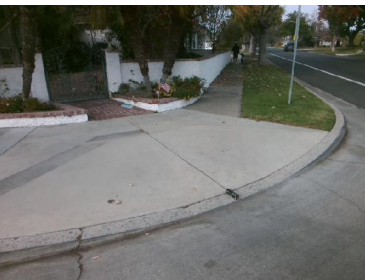
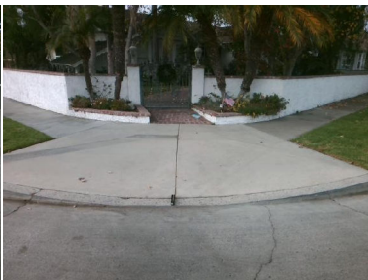
| Compliance | Description | Data | Compliance | Description | Data |
|---|---|---|---|---|---|
| No | Landing Run Slope (%) | 5 | N/A | Flare Traversable RT | No |
| Yes | Landing Cross Slope (%) | 0.7 | No | DWS Provided | No |
| Yes | Gutter Ponding | No | No | Curb Slope | 5.5 |

Remove & Replace Curb Ramp With Two New Directional Ramps or Equivalent.

Total Cost: \$ 6160
