# Access Compliance Report Public Rights-of-Way (Curb Ramps)

| Main Street: N/A | | Cross Street: FLINTRIDGE_AVE | | Location: | W |
| ADA ID: RPAT220125091415 | Ramp Type: Type 4 - Parallel | Initial Pass/Fail: Fail | Overall Compliance: No | Severity Score: | 2 |

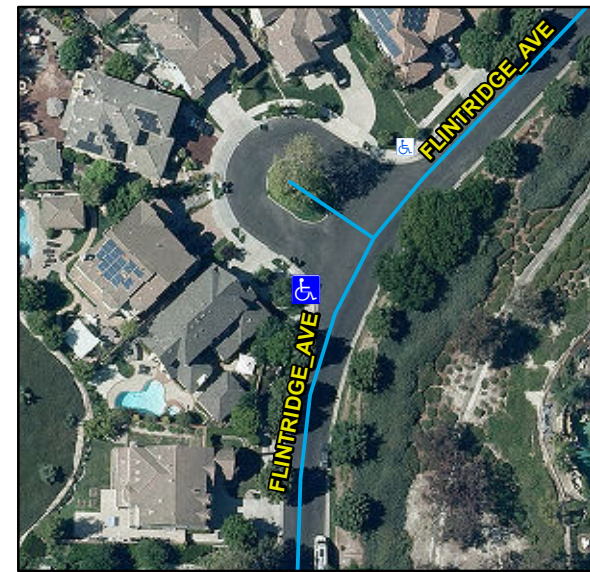
R204.3, R304.5.3, STD 1115

| Compliance | Description | Data | Compliance | Description | Data |
|---|---|---|---|---|---|
| No | Ramp Cross Slope LT (%) | 3.5 | Yes | Ramp Cross Slope RT (%) | 2 |

Remove & Replace Entire Ramp.
