# Access Compliance Report Public Rights-of-Way (Curb Ramps)

Main Street: N/A Cross Street: FLINTRIDGE\_AVE Location: NW

ADA ID: RPAT220125094853 Ramp Type: Type 4 - Parallel Initial Pass/Fail: Fail Overall Compliance: No Severity Score: 15

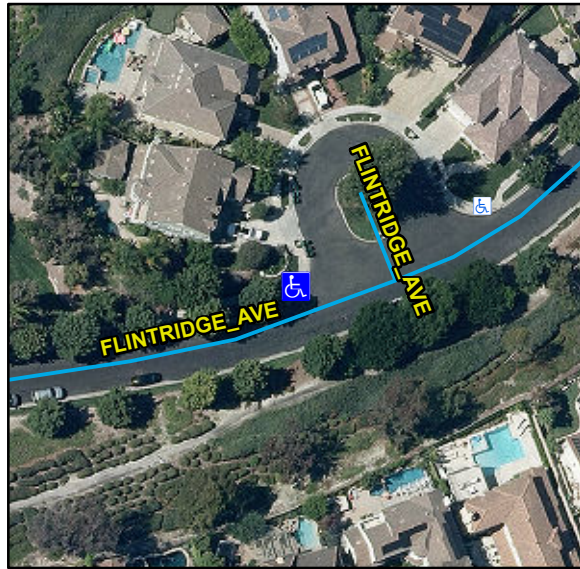
| Compliance | Description | Data | Compliance | Description | Data |
|---|---|---|---|---|---|
| Yes | Ramp Run Slope LT (%) | 0.2 | No | Ramp Run Slope RT (%) | 10 |

Remove & Replace Entire Ramp.
