# Access Compliance Report Public Rights-of-Way (Curb Ramps)

| Main Street: N/A | | Cross Street: AVENDALE_BLVD | | Location: | NE |
| ADA ID: RPAT220125101337 | Ramp Type: Type 4 - Parallel | Initial Pass/Fail: Pass | Overall Compliance: No | Severity Score: | 20 |

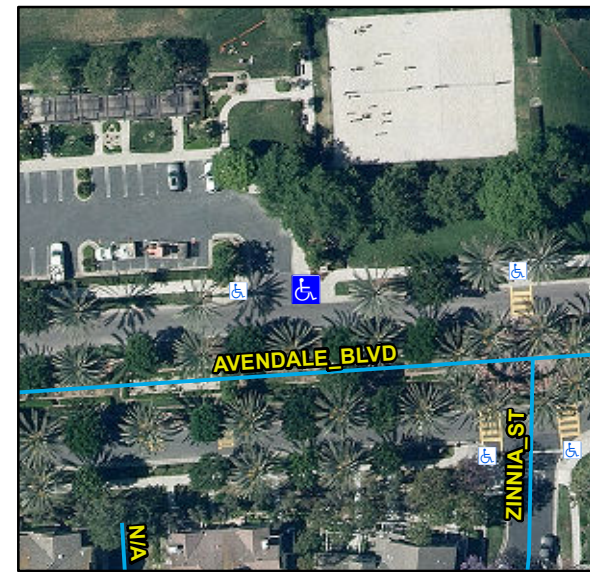
| Compliance | Description | Data | Compliance | Description | Data |
|---|---|---|---|---|---|
| No | Landing Width (in) | N/A | N/A | DWS Length (in) | N/A |
| No | Landing Run Slope (%) | N/A | N/A | DWS Full Width | N/A |
| No | Landing Cross Slope (%) | N/A | | DWS Offset Type | N/A |
| No | Gutter Ponding | Yes | No | Curb Slope | 19.5 |
| No | Gutter Cross Slope (%) | 2.1 | No | Perpendicular Joint Present | No |

**Remove & Replace Entire Ramp. Remove & Replace Gutter.**

**R304.2.2, R204.3, R304.2.1, R304.2.2-Perp, R304.3.2-Para, R304.5.3, R305, R302.7, STD 1115**

Total Cost: \$ 2252

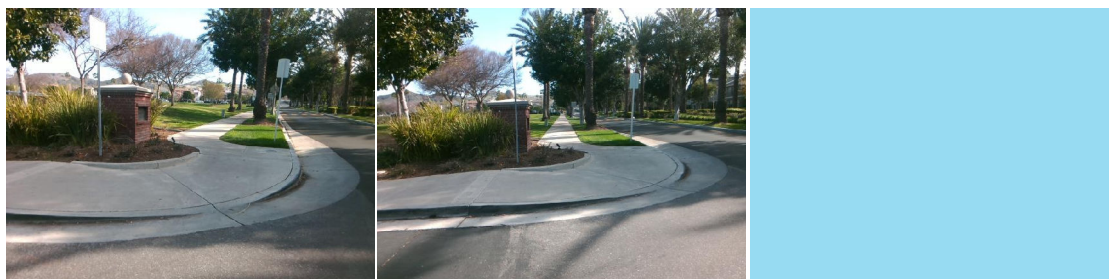
| Compliance | Description | Data | Compliance | Description | Data |
|---|---|---|---|---|---|
| Yes | Obstructions Present? | No | N/A | Utilities Present? | No |
| | Obstruction Types | N/A | | Utility Types | |
| | Obstruction Dimensions | N/A | | | N/A |
