# Access Compliance Report Public Rights-of-Way (Curb Ramps)

| Main Street: N/A | | Cross Street: AVENDALE BLVD | | Location: | NW |
| ADA ID: RPAT220125102240 | Ramp Type: Type 4 - Parallel | Initial Pass/Fail: Fail | Overall Compliance: No | Severity Score: | 2 |

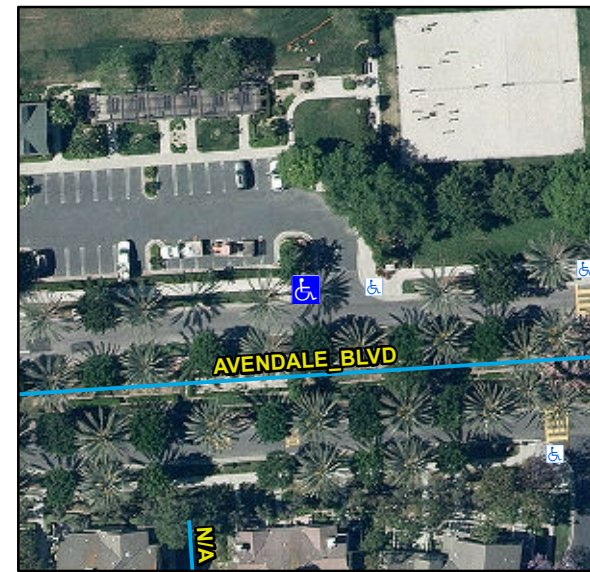
| Compliance | Description | Data | Compliance | Description | Data |
|---|---|---|---|---|---|
| Yes | Ramp Cross Slope LT (%) | 1.2 | No | Ramp Cross Slope RT (%) | 3 |
| N/A | Gutter Cross Slope (%) | N/A | No | Perpendicular Joint Present | No |

Remove & Replace Entire Ramp.

R204.3, R304.5.3, STD 1115
