# Access Compliance Report Public Rights-of-Way (Curb Ramps)

Main Street: N/A Cross Street: AVENDALE\_BLV Location: NE

ADA ID: RPAT220125102628 Ramp Type: Type 4 - Parallel Initial Pass/Fail: Fail Overall Compliance: No Severity Score: 15

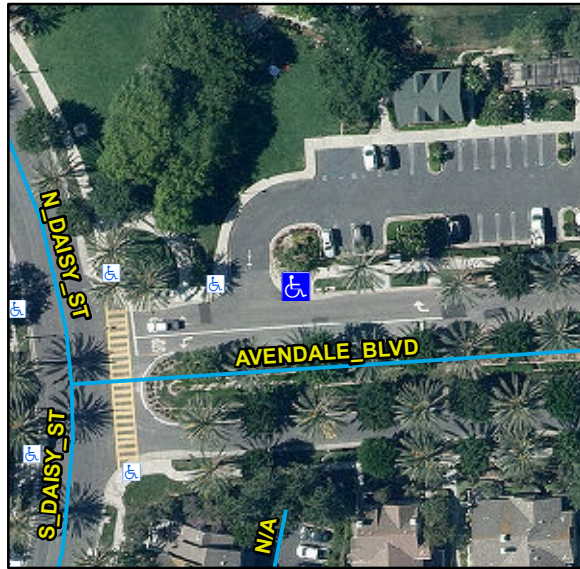
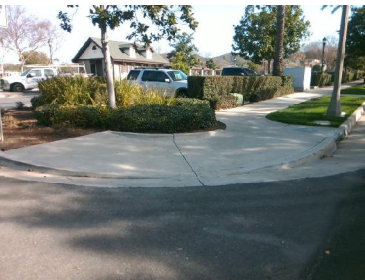
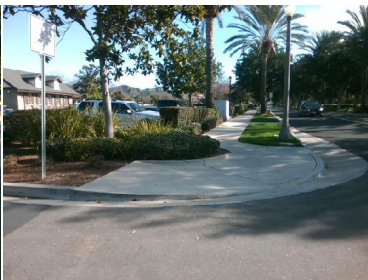
| Compliance | Description | Data | Compliance | Description | Data |
|---|---|---|---|---|---|
| Yes | Ramp Run Slope LT (%) | 6.4 | No | Ramp Run Slope RT (%) | 8.9 |

Remove & Replace Entire Ramp.
