# Access Compliance Report Public Rights-of-Way (Curb Ramps)

Main Street: N/A Cross Street: AVENDALE\_BLV Location: NW

ADA ID: RPAT220125102913 Ramp Type: Type 4 - Parallel Initial Pass/Fail: Fail Overall Compliance: No Severity Score: 2

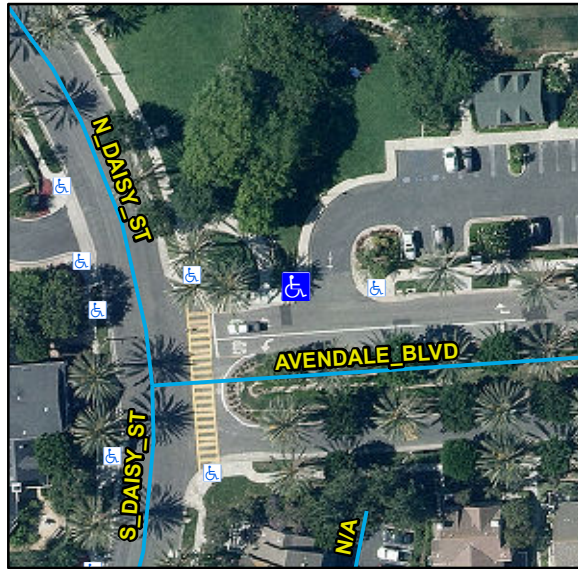
| Compliance | Description | Data | Compliance | Description | Data |
|---|---|---|---|---|---|
| Yes | Ramp Run Slope LT (%) | 2.4 | Yes | Ramp Run Slope RT (%) | 7 |
| No | Ramp Cross Slope LT (%) | 2.3 | No | Ramp Cross Slope RT (%) | 2.4 |

Remove & Replace Entire Ramp.

R204.3, R304.5.3, STD 1115
