# Access Compliance Report Public Rights-of-Way (Curb Ramps)

Main Street: CIMA\_DR Cross Street: N/A Location: W

ADA ID: RPAT220125111012 Ramp Type: Type 1 - Perpendicular Initial Pass/Fail: Pass Overall Compliance: No Severity Score: 5

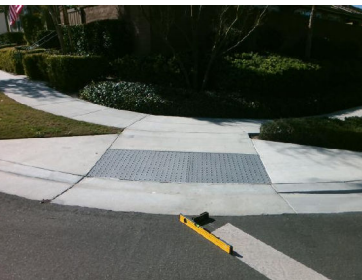
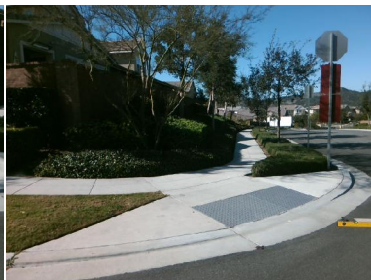
| Compliance | Description | Data | Compliance | Description | Data |
|---|---|---|---|---|---|
| No | Gutter Ponding | Yes | No | Curb Slope | 9 |
| No | Gutter Run Slope (%) | 6.8 | | Road Cross Slope (%) | N/A |
| No | Gutter Cross Slope (%) | 2.7 | | | |

Remove & Replace Entire Ramp. Remove & Replace Gutter.
