# Access Compliance Report Public Rights-of-Way (Curb Ramps)

| Main Street: N/A | | Cross Street: ESENCIA_DR | | Location: | NE |
| ADA ID: RPAT220125112513 | Ramp Type: Type 6 - Directional 1 | Initial Pass/Fail: Fail | Overall Compliance: No | Severity Score: | 15 |

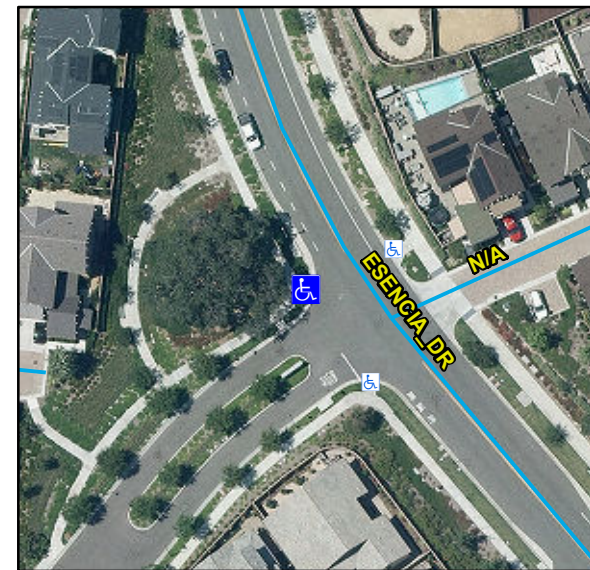
| Compliance | Description | Data | Compliance | Description | Data |
|---|---|---|---|---|---|
| No | Ramp Run Slope (%) | 9 | N/A | Flare Slope LT (%) | N/A |

**Remove & Replace Curb Ramp With Two New Directional Ramps or Equivalent.**

**R304.2.2, STD 1115**

Total Cost: \$ 3080

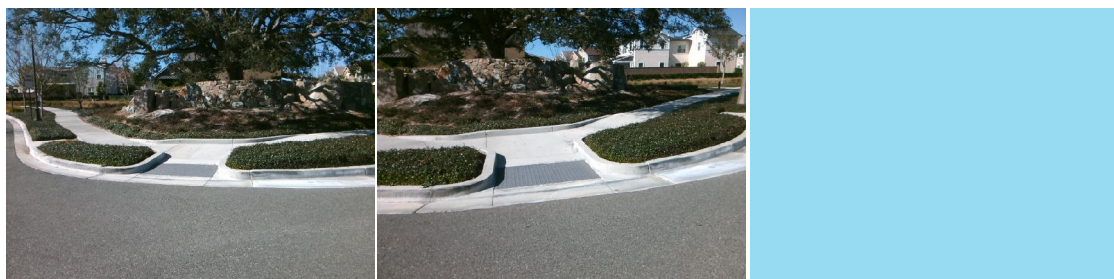
| Compliance | Description | Data | Compliance | Description | Data |
|---|---|---|---|---|---|
| N/A | Ramp Length (in) | 53 | N/A | Flare Type LT | |
| Yes | Ramp Width (in) | 60 | | | N/A |
| Yes | Ramp Cross Slope (%) | 0.4 | N/A | Flare Traversable LT | N/A |
