# Access Compliance Report Public Rights-of-Way (Curb Ramps)

Main Street: ESENCIA\_DR Cross Street: N/A Location: SE

ADA ID: RPAT220125113028 Ramp Type: Type 6 - Directional 1 Initial Pass/Fail: Fail Overall Compliance: No Severity Score: 15

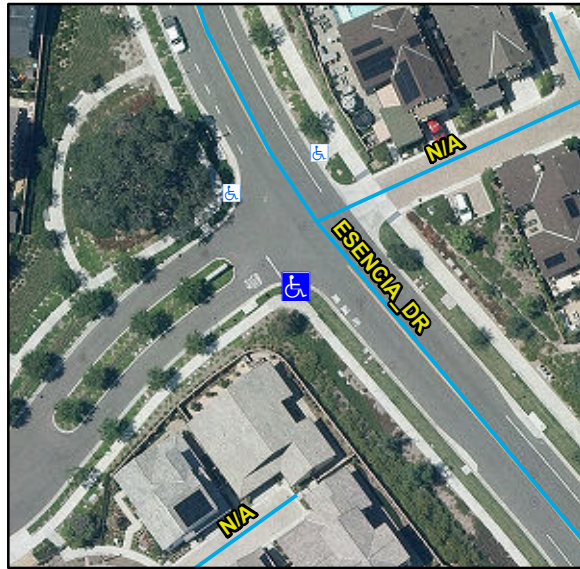
| Compliance | Description | Data | Compliance | Description | Data |
|---|---|---|---|---|---|
| No | Ramp Run Slope (%) | 9.8 | N/A | Flare Slope LT (%) | N/A |

**Remove & Replace Curb Ramp With Two New Directional Ramps or Equivalent.**

**R304.2.2, STD 1115**
