# Access Compliance Report Public Rights-of-Way (Curb Ramps)

| Main Street: ESENCIA_DR | | Cross Street: ESENCIA_DR | | Location: | NE |
| ADA ID: RPAT220125113752 | Ramp Type:Type 1 - Perpendicular | Initial Pass/Fail: Pass | Overall Compliance: No | Severity Score: | 5 |

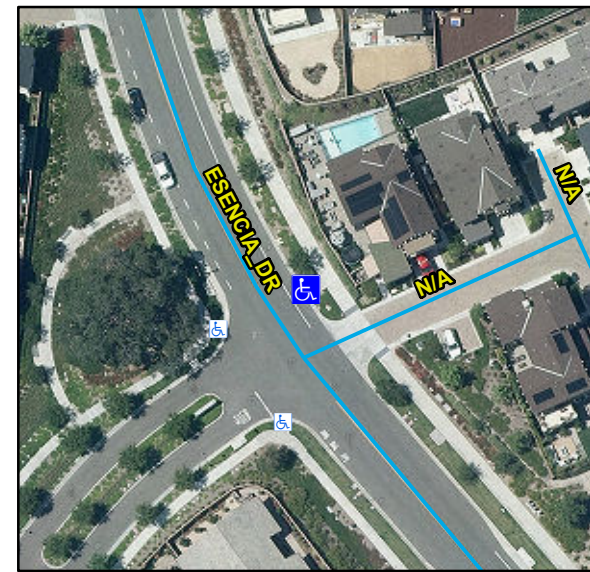
| Compliance | Description | Data | Compliance | Description | Data |
|---|---|---|---|---|---|
| No | Landing Run Slope (%) | 8.1 | N/A | Flare Traversable RT | No |
| Yes | Gutter Ponding | No | No | Curb Slope | 8.3 |

Possible Solutions:

Remove & Replace Entire Ramp.

R304.2.2, R304.2.2-Perp, R304.3.2-Para, STD 1115

Total Cost: \$ 3080
