# Access Compliance Report Public Rights-of-Way (Curb Ramps)

Main Street: N/A Cross Street: ANDAZA\_ST Location: S

ADA ID: RPAT220125114636 Ramp Type: Type 1 - Perpendicular Diagonal Initial Pass/Fail: Pass Overall Compliance: No Severity Score: 6

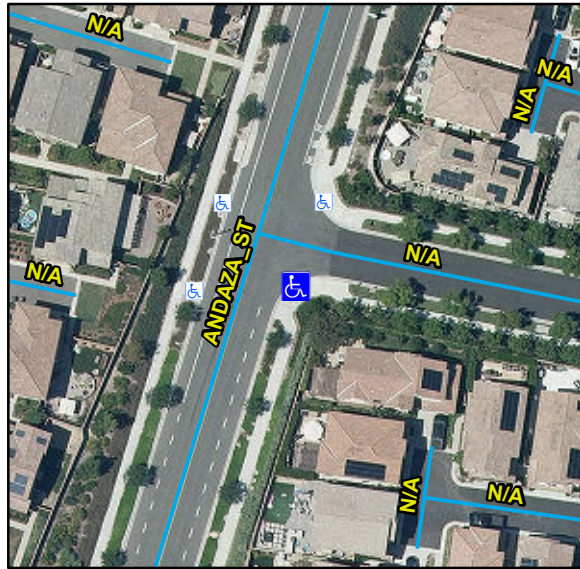
R304.2.2, R304.5.3, R304.2.1, STD 1115

| Compliance | Description | Data | Compliance | Description | Data |
|---|---|---|---|---|---|
| No | Ramp Cross Slope (%) | 2.1 | N/A | Flare Traversable LT | Yes |
| No | Landing Cross Slope (%) | 8.4 | Yes | DWS Provided | Yes |
| Yes | Gutter Ponding | No | No | Curb Slope | 7 |

Remove & Replace Curb Ramp With Two New Directional Ramps or Equivalent.

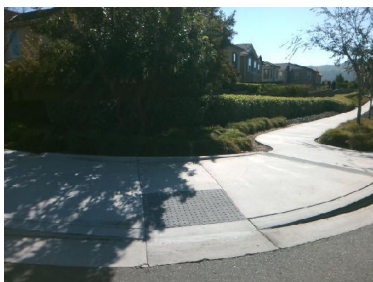
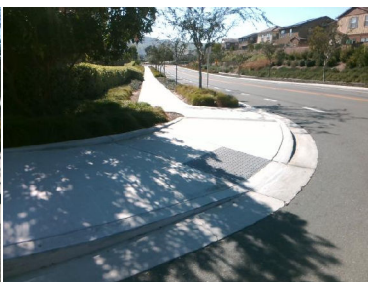
| Compliance | Description | Data | Compliance | Description | Data |
|---|---|---|---|---|---|
| Yes | Overall Surface Condition: Acceptable | | Yes | Perp Joint Present | Yes |
