# Access Compliance Report Public Rights-of-Way (Curb Ramps)

Main Street: ANDAZA\_ST Cross Street: N/A Location: E

ADA ID: RPAT220125115442 Ramp Type: Type 1 - Perpendicular Diagonal Initial Pass/Fail: Pass Overall Compliance: No Severity Score: 6

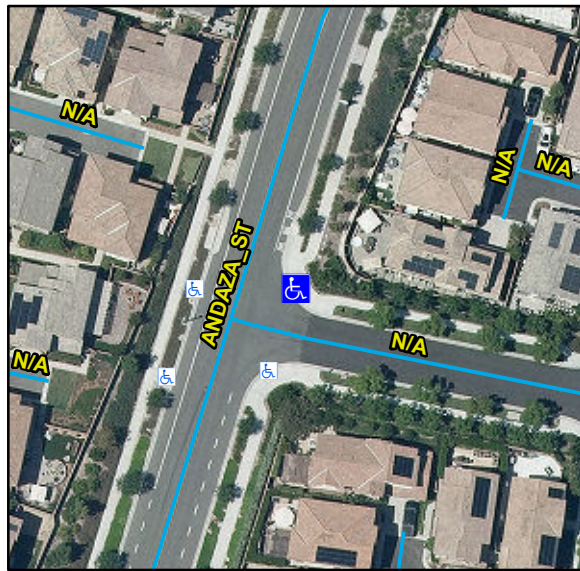
| Compliance | Description | Data | Compliance | Description | Data |
|---|---|---|---|---|---|
| No | Ramp Cross Slope (%) | 3 | N/A | Flare Traversable LT | Yes |
| No | Landing Cross Slope (%) | 8.5 | Yes | DWS Provided | Yes |
| No | Gutter Cross Slope (%) | 3.7 | | | |

Remove & Replace Curb Ramp With Two New Directional Ramps or Equivalent. Remove & Replace Gutter.

R304.2.2, R304.5.3, R304.2.1, STD 1115

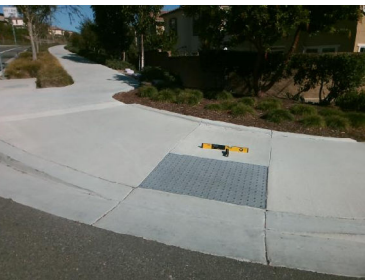
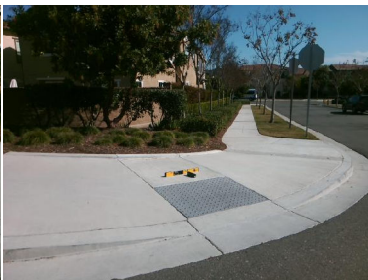
| Compliance | Description | Data | Compliance | Description | Data |
|---|---|---|---|---|---|
| Yes | Overall Surface Condition: Acceptable | | Yes | Perp Joint Present | Yes |
