# Access Compliance Report Public Rights-of-Way (Curb Ramps)

| Main Street: ANDAZA_ST | | Cross Street: ANDAZA_ST | | Location: | W |
| ADA ID: RPAT220125120046 | Ramp Type:Type 1 - Perpendicular | Initial Pass/Fail: Fail | Overall Compliance: No | Severity Score: | 15 |

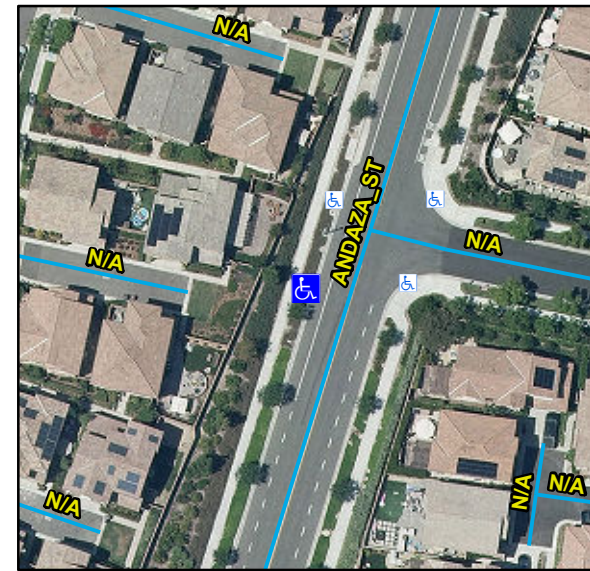
| Compliance | Description | Data | Compliance | Description | Data |
|---|---|---|---|---|---|
| No | Ramp Run Slope (%) | 9.2 | N/A | Flare Slope LT (%) | N/A |
| N/A | Gutter Ponding | N/A | No | Curb Slope | 6.8 |

**Remove & Replace Entire Ramp.**

**R304.2.2, STD 1115**
