# Access Compliance Report Public Rights-of-Way (Curb Ramps)

Main Street: DUNTON\_AVE Cross Street: DELL\_ST Location: NW

ADA ID: RPAT220126131103 Ramp Type: Type 1 - Perpendicular Diagonal Initial Pass/Fail: Pass Overall Compliance: No Severity Score: 22

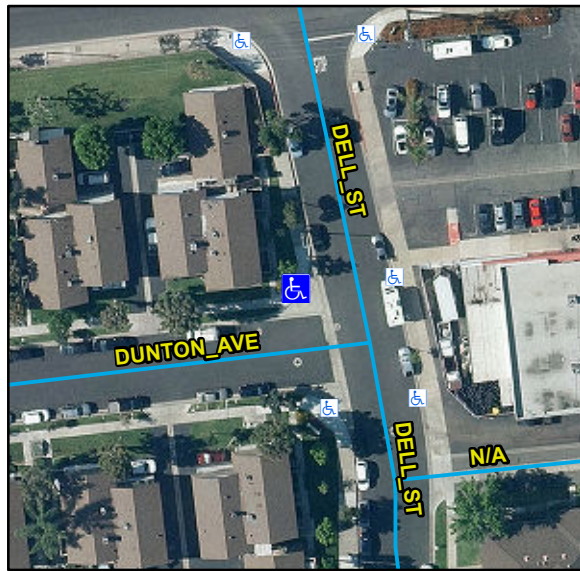
| Compliance | Description | Data | Compliance | Description | Data |
|---|---|---|---|---|---|
| Yes | Gutter Ponding | No | No | Curb Slope | 9.7 |
| No | Gutter Run Slope (%) | 5.1 | | Road Cross Slope (%) | 4 |
| No | Overall Surface Condition: | Poor | Yes | Perp Joint Present | Yes |

Remove & Replace Curb Ramp With Two New Directional Ramps or Equivalent. Remove & Replace Gutter.

R304.2.2, R302.7, R304.2.1, R304.5.4, STD 1115
