# Access Compliance Report Public Rights-of-Way (Curb Ramps)

Main Street: FRONTERA\_ST Cross Street: N\_GLASSELL\_ST Location: SE

ADA ID: RPAT220127090333 Ramp Type: Type 1 - Perpendicular Diagonal Initial Pass/Fail: Fail Overall Compliance: No Severity Score: 4

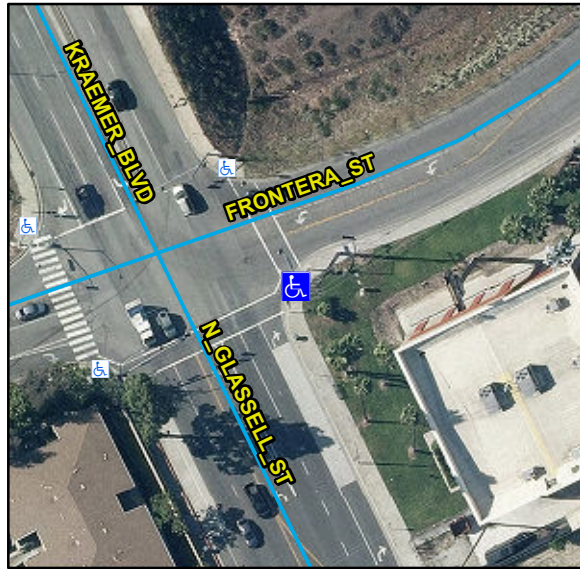
| Compliance | Description | Data | Compliance | Description | Data |
|---|---|---|---|---|---|
| No | Ramp Width (in) | 44 | | | N/A |

Remove & Replace Curb Ramp With Two New Directional Ramps or Equivalent.

R204.3, R304.5.1, STD 1115
