# Access Compliance Report Public Rights-of-Way (Curb Ramps)

Main Street: N\_GLASSELL\_ST Cross Street: FRONTERA\_ST Location: SW

ADA ID: RPAT220127093014 Ramp Type: Type 1 - Perpendicular Diagonal Initial Pass/Fail: Fail Overall Compliance: No Severity Score: 2

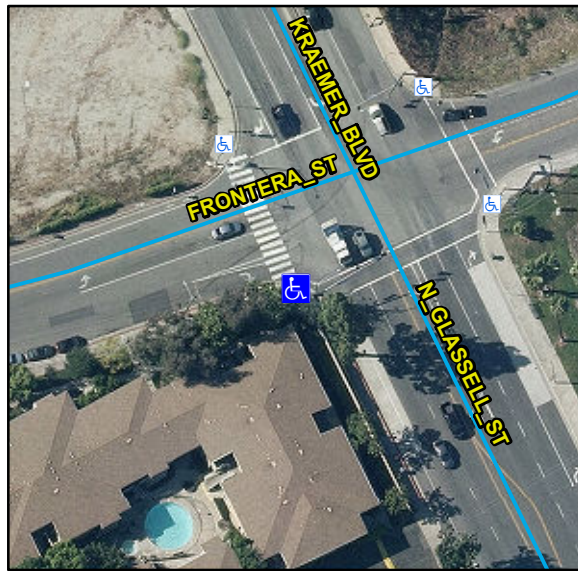
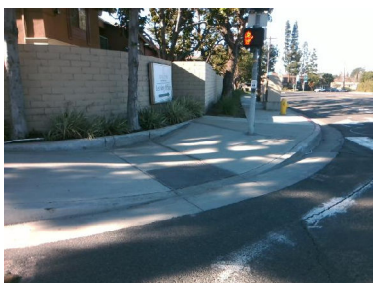
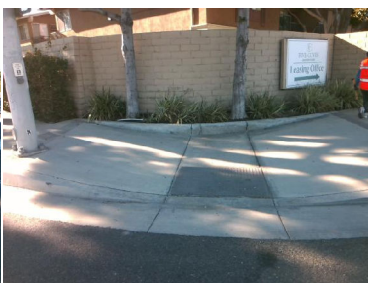
| Compliance | Description | Data | Compliance | Description | Data |
|---|---|---|---|---|---|
| No | Ramp Cross Slope (%) | 2.3 | N/A | Flare Traversable LT | N/A |
| N/A | Gutter Ponding | N/A | No | Curb Slope | 6.4 |

Remove & Replace Curb Ramp With Two New Directional Ramps or Equivalent.

R304.2.2, R304.5.3, STD 1115
