# Access Compliance Report Public Rights-of-Way (Curb Ramps)

Main Street: N/A Cross Street: LINCOLN\_AVE Location: NE

ADA ID: RPAT220127115108 Ramp Type: Type 1 - Perpendicular Initial Pass/Fail: Fail Overall Compliance: No Severity Score: 4

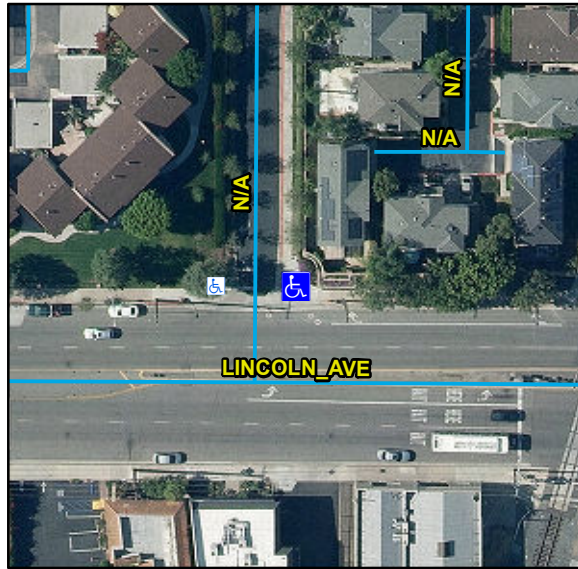
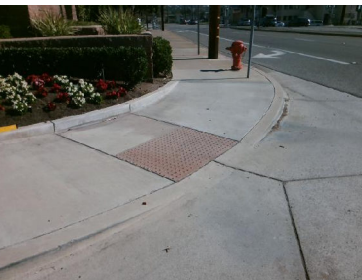
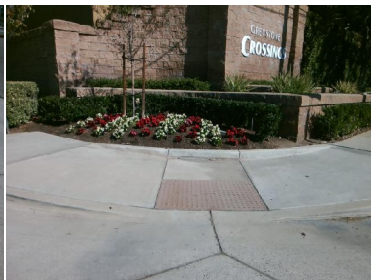
| Compliance | Description | Data | Compliance | Description | Data |
|---|---|---|---|---|---|
| No | Ramp Width (in) | 45 | | | N/A |
| N/A | Gutter Ponding | N/A | No | Curb Slope | 10.9 |

Possible Solutions:

Remove & Replace Entire Ramp.

R304.2.2, R304.5.1, STD 1115
