# Access Compliance Report Public Rights-of-Way (Curb Ramps)

Main Street: N/A Cross Street: LINCOLN\_AVE Location: NW

ADA ID: RPAT220127115547 Ramp Type: Type 7 - Directional 2 Initial Pass/Fail: Fail Overall Compliance: No Severity Score: 2

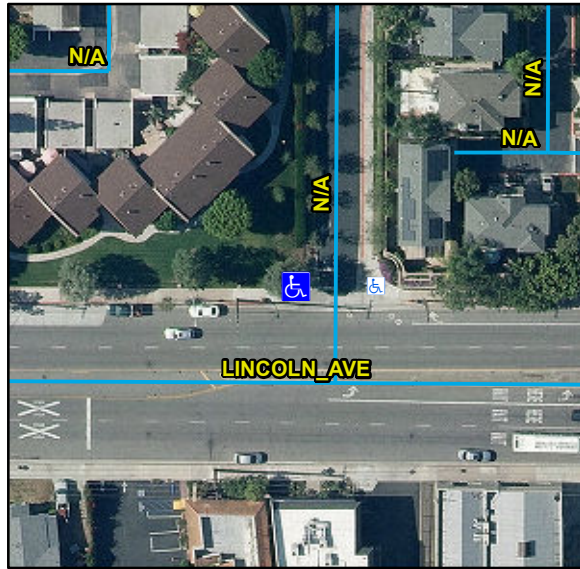
| Compliance | Description | Data | Compliance | Description | Data |
|---|---|---|---|---|---|
| No | Ramp Cross Slope (%) | 2.2 | N/A | Flare Traversable LT | N/A |

Remove & Replace Entire Ramp.
