# Access Compliance Report Public Rights-of-Way (Curb Ramps)

Main Street: MAIN\_ST Cross Street: ORANGE\_OLIVE\_RD Location: E

ADA ID: RPAT220127120500 Ramp Type: Type 7 - Directional 2 Initial Pass/Fail: Fail Overall Compliance: No Severity Score: 2

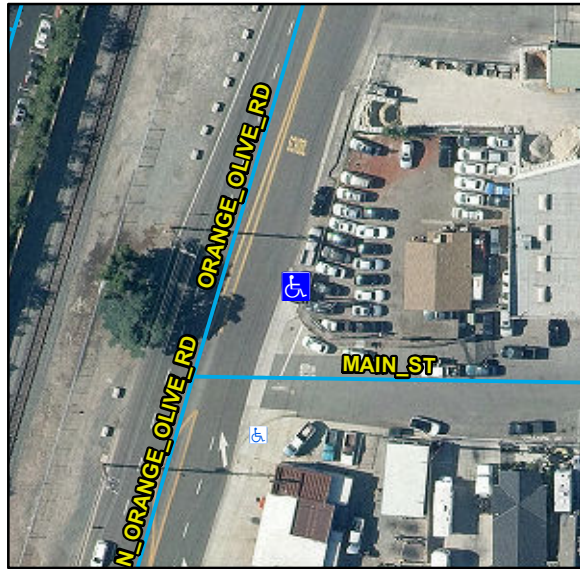
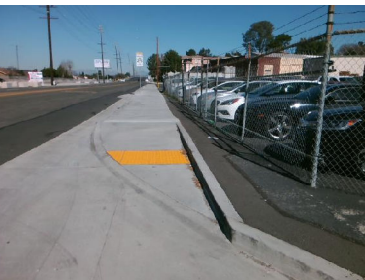
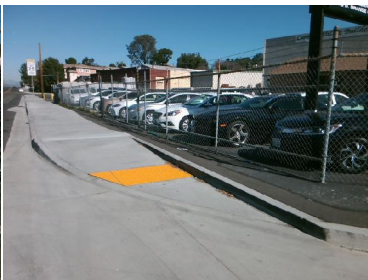
| Compliance | Description | Data | Compliance | Description | Data |
|---|---|---|---|---|---|
| No | Ramp Cross Slope (%) | 2.6 | N/A | Flare Traversable LT | N/A |

Remove & Replace Entire Ramp.

R304.5.3, STD 1115
