# Access Compliance Report Public Rights-of-Way (Curb Ramps)

| Main Street: OLIVE_AVE | | Cross Street: ORANGE_OLIVE_RD | | Location: | SE |
| ADA ID: RPAT220127121650 | Ramp Type:Type 1 - Perpendicular | Initial Pass/Fail: Fail | Overall Compliance: No | Severity Score: | 16 |

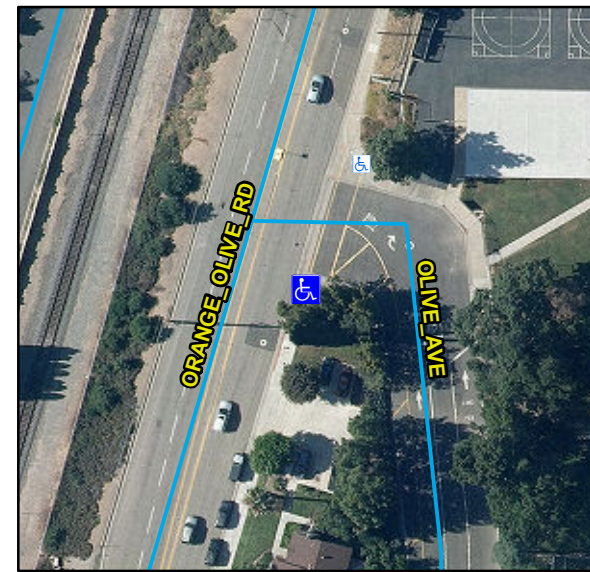
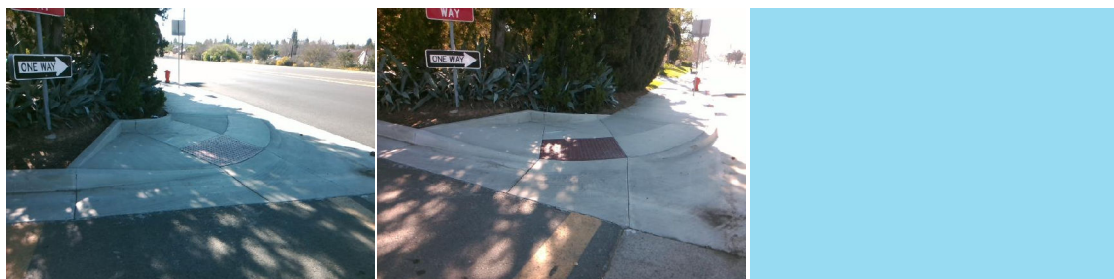
| Compliance | Description | Data | Compliance | Description | Data |
|---|---|---|---|---|---|
| No | Ramp Run Slope (%) | 8.8 | N/A | Flare Slope LT (%) | N/A |
| No | Ramp Cross Slope (%) | 2.2 | N/A | Flare Traversable LT | N/A |
| N/A | Ramp Inside Crosswalk 1 | No | Yes | Ramp Inside Crosswalk 2 | N/A |

**Remove & Replace Entire Ramp. Restripe Crosswalk.**

**R304.2.2, R304.5.3, STD 1115**
