# Access Compliance Report Public Rights-of-Way (Curb Ramps)

Main Street: OLIVE\_AVE Cross Street: ORANGE\_OLIVE\_RD Location: E

ADA ID: RPAT220127121939 Ramp Type:Type 1 - Perpendicular Initial Pass/Fail: Pass Overall Compliance: No Severity Score: 9

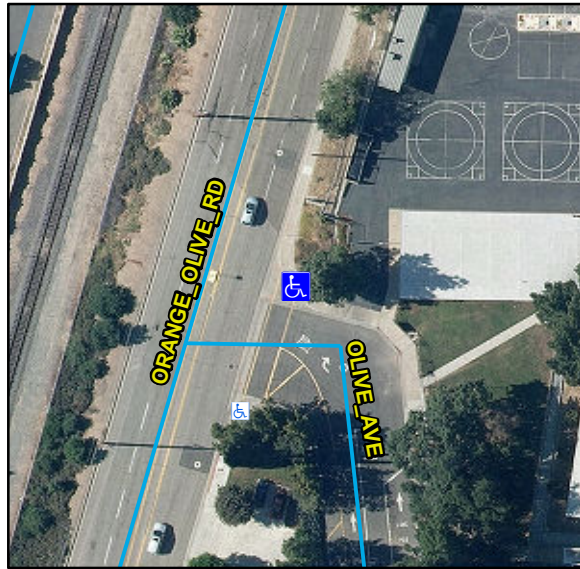
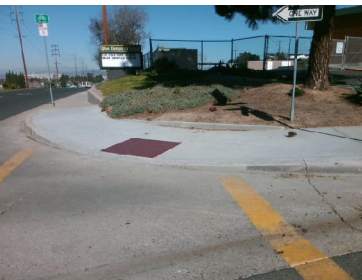
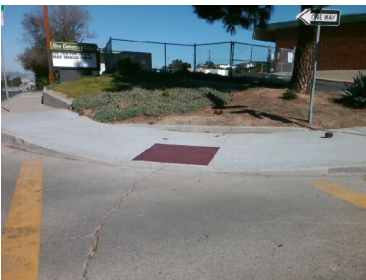
| Compliance | Description | Data | Compliance | Description | Data |
|---|---|---|---|---|---|
| Yes | Gutter Ponding | No | No | Curb Slope | 10.1 |
| No | Gutter Run Slope (%) | 9.7 | | Road Cross Slope (%) | N/A |

### Possible Solutions:

Remove & Replace Entire Ramp. Remove & Replace Gutter.

R304.2.2, R304.2.1, R304.5.4, STD 1115
