# Access Compliance Report Public Rights-of-Way (Curb Ramps)

Main Street: DEL\_MAR\_AVE Cross Street: SANTA\_ANA\_AVE Location: N

ADA ID: RPAT220128161740 Ramp Type: Type 1 - Perpendicular Diagonal Initial Pass/Fail: Pass Overall Compliance: No Severity Score: 26

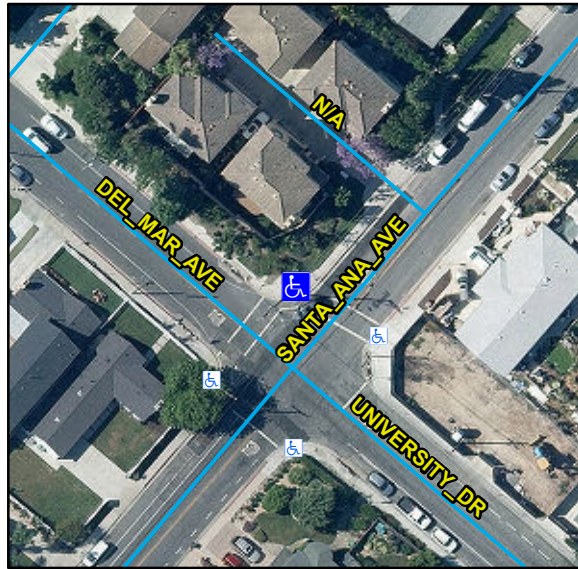
| Compliance | Description | Data | Compliance | Description | Data |
|---|---|---|---|---|---|
| No | Landing Run Slope (%) | 4.1 | N/A | Flare Traversable RT | N/A |
| No | Landing Cross Slope (%) | 2.3 | No | DWS Provided | No |
| Yes | Gutter Ponding | No | No | Curb Slope | 7.7 |
| No | Gutter Lip Height (in) | 1.5 | | Road Run Slope (%) | 0.8 |
| No | Gutter Run Slope (%) | 6.6 | | Road Cross Slope (%) | 1.8 |

Remove & Replace Curb Ramp With Two New Directional Ramps or Equivalent. Remove & Replace Gutter. Utility Present.

R304.2.2, R304.2.2-Perp, R304.3.2-Para, R304.5.3, R305, R302.7.2, R304.5.4, STD 1115
