# Access Compliance Report Public Rights-of-Way (Curb Ramps)

Main Street: SANTA\_ANA\_AVE Cross Street: DEL\_MAR\_AVE Location: NW

ADA ID: RPAT220128162736 Ramp Type: Type 1 - Perpendicular Diagonal Initial Pass/Fail: Fail Overall Compliance: No Severity Score: 45

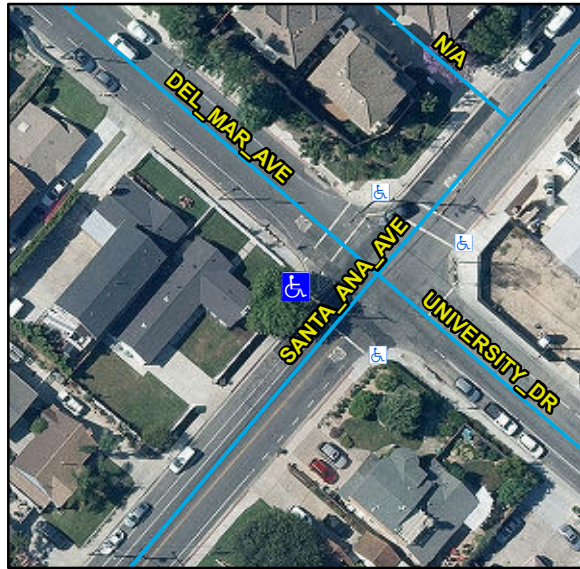
| Compliance | Description | Data | Compliance | Description | Data |
|---|---|---|---|---|---|
| No | Ramp Run Slope (%) | 13.9 | N/A | Flare Slope LT (%) | N/A |
| No | Gutter Lip Height (in) | 0.5 | | Road Run Slope (%) | 0.6 |
| No | Overall Surface Condition: | Poor | No | Perp Joint Present | No |

Remove & Replace Curb Ramp With Two New Directional Ramps or Equivalent.
