# Access Compliance Report Public Rights-of-Way (Curb Ramps)

Main Street: SANTO\_TOMAS\_ST Cross Street: SANTA\_ANA\_AVE Location: W

ADA ID: RPAT220128164805 Ramp Type: Type 4 - Parallel Initial Pass/Fail: Pass Overall Compliance: No Severity Score: 34

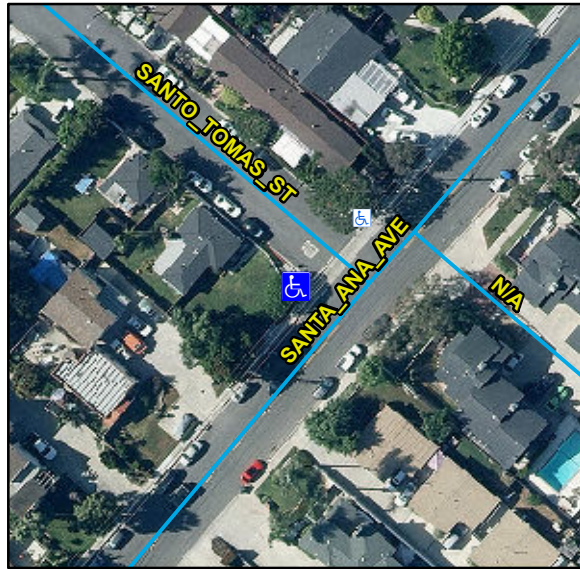
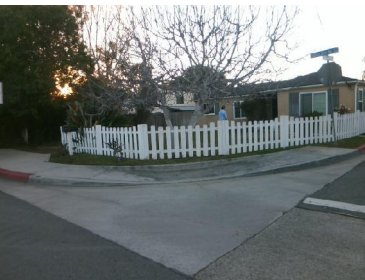
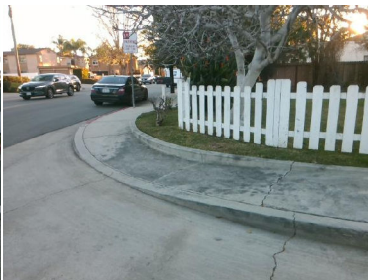
| Compliance | Description | Data | Compliance | Description | Data |
|---|---|---|---|---|---|
| No | Gutter Lip Height (in) | 0.5 | | Road Run Slope (%) | N/A |
| No | Gutter Run Slope (%) | 13.4 | | Road Cross Slope (%) | N/A |
| No | Gutter Cross Slope (%) | 2.4 | Yes | Perpendicular Joint Present | Yes |
| No | Overall Surface Condition | Poor | | | |
| | Replace Cross Gutter? | No | | Replace Spandrel? | Yes |

Remove & Replace Entire Ramp. Remove & Replace Gutter. Replace Spandrel.
