# Access Compliance Report Public Rights-of-Way (Curb Ramps)

Main Street: SANTA\_ANA\_AVE Cross Street: MESA\_DR Location: NW

ADA ID: RPAT220128171746 Ramp Type: Type 1 - Perpendicular Diagonal Initial Pass/Fail: Pass Overall Compliance: No Severity Score: 6

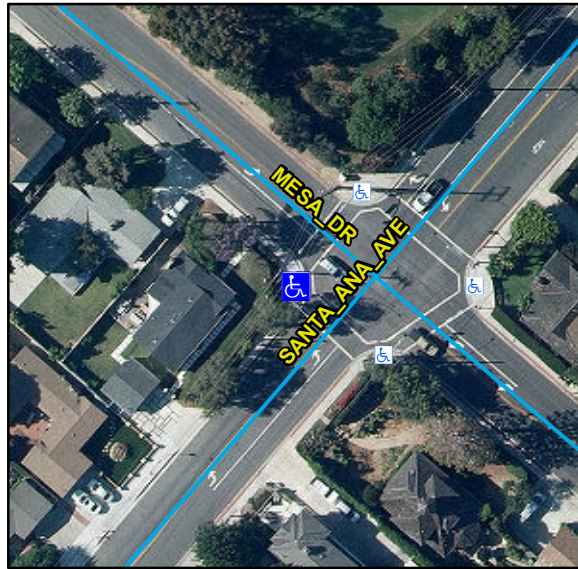
| Compliance | Description | Data | Compliance | Description | Data |
|---|---|---|---|---|---|
| No | Landing Cross Slope (%) | 2.3 | Yes | DWS Provided | Yes |
| N/A | Landing Shared | No | No | DWS Full Width | No |
| No | Gutter Cross Slope (%) | 2.1 | | | |

**Remove & Replace Curb Ramp With Two New Directional Ramps or Equivalent. Remove & Replace Gutter. Utility Present.**

**R304.2.1, R304.5.3, R305.1.4, STD 1115**
