# Access Compliance Report Public Rights-of-Way (Curb Ramps)

Main Street: MESA\_DR Cross Street: SANTA\_ANA\_AVE Location: N

ADA ID: RPAT220128173117 Ramp Type: Type 1 - Perpendicular Diagonal Initial Pass/Fail: Pass Overall Compliance: No Severity Score: 5

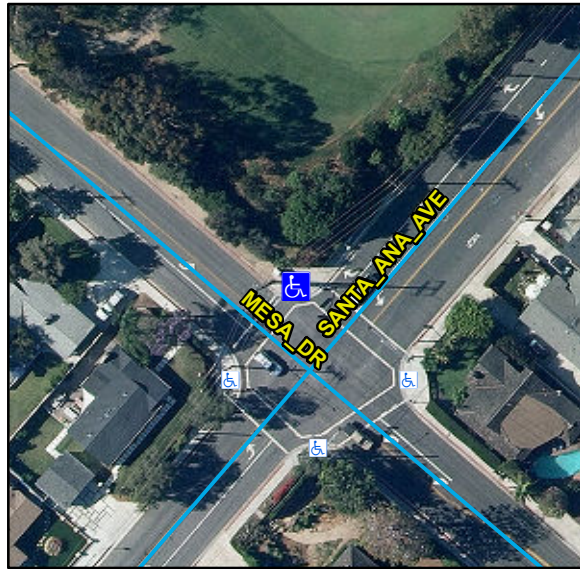
| Compliance | Description | Data | Compliance | Description | Data |
|---|---|---|---|---|---|
| Yes | Gutter Ponding | No | No | Curb Slope | 10 |
| No | Gutter Run Slope (%) | 7.1 | | Road Cross Slope (%) | 4.2 |

Remove & Replace Curb Slope. Remove & Replace Gutter. Utility Present.

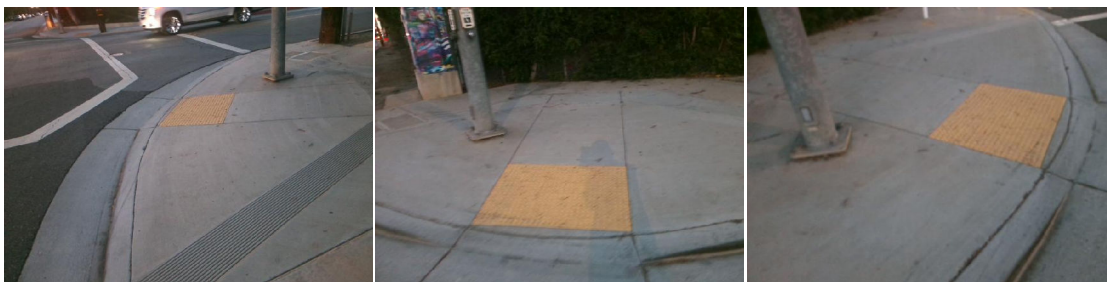
| Compliance | Description | Data | Compliance | Description | Data |
|---|---|---|---|---|---|
| Yes | Overall Surface Condition: Acceptable | | Yes | Perp Joint Present | Yes |
| | Cross Gutter Present? | No | | Spandrel Present? | No |
| | Replace Cross Gutter? | N/A | | Replace Spandrel? | N/A |
