# Access Compliance Report Public Rights-of-Way (Curb Ramps)

Main Street: SANTA\_ANA\_AVE Cross Street: MESA\_DR Location: SE

ADA ID: RPAT220128174225 Ramp Type: Type 1 - Perpendicular Diagonal Initial Pass/Fail: Pass Overall Compliance: No Severity Score: 0

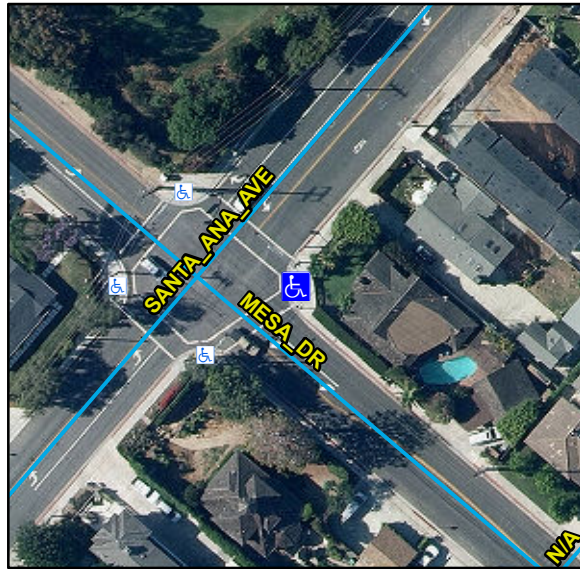
| Compliance | Description | Data | Compliance | Description | Data |
|---|---|---|---|---|---|
| Yes | Gutter Ponding | No | No | Curb Slope | 6.6 |

Remove & Replace Curb Slope. Utility Present.

R304.2.2, STD 1115
