# Access Compliance Report Public Rights-of-Way (Curb Ramps)

Main Street: KATELLA\_AVE Cross Street: MAC\_ST Location: SE

ADA ID: RPAT220201103642 Ramp Type: Type 4 - Parallel Initial Pass/Fail: Fail Overall Compliance: No Severity Score: 16

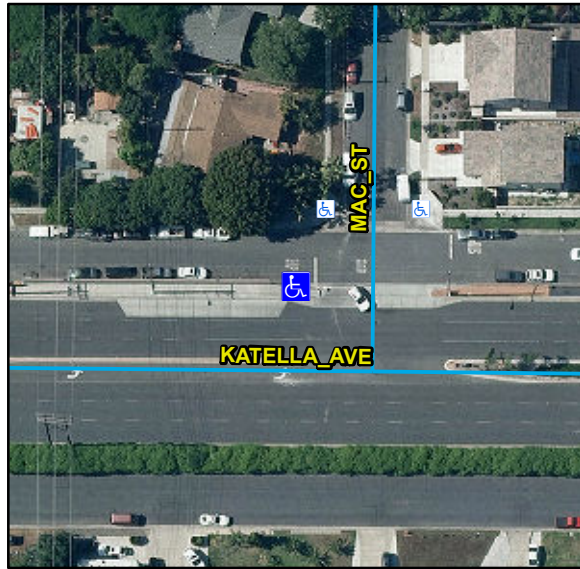
| Compliance | Description | Data | Compliance | Description | Data |
|---|---|---|---|---|---|
| N/A | Ramp Cross Slope LT (%) | -9999 | No | Ramp Cross Slope RT (%) | 2.3 |

Remove & Replace Entire Ramp.

R304.5.3, STD 1115
