# Access Compliance Report Public Rights-of-Way (Curb Ramps)

Main Street: MACNAB\_ST Cross Street: REGAL\_AVE Location: NW

ADA ID: RPAT220201105355 Ramp Type: Type 7 - Directional 2 Initial Pass/Fail: Fail Overall Compliance: No Severity Score: 0

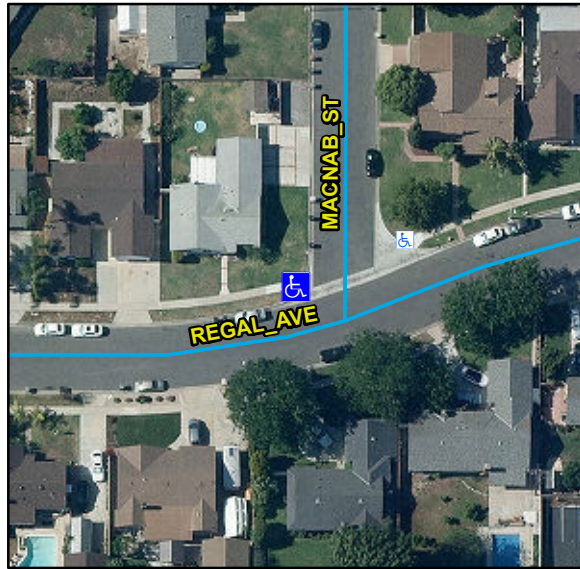
R304.2.2, STD 1115

| Compliance | Description | Data | Compliance | Description | Data |
|---|---|---|---|---|---|
| N/A | Gutter Ponding | N/A | No | Curb Slope | 10 |

Remove & Replace Entire Ramp.
