# Access Compliance Report Public Rights-of-Way (Curb Ramps)

Main Street: MAGNOLIA\_AVE Cross Street: MAGNOLIA\_AVE Location: SW

ADA ID: RPAT220202093037 Ramp Type: Type 1 - Perpendicular Diagonal Initial Pass/Fail: Pass Overall Compliance: No Severity Score: 0

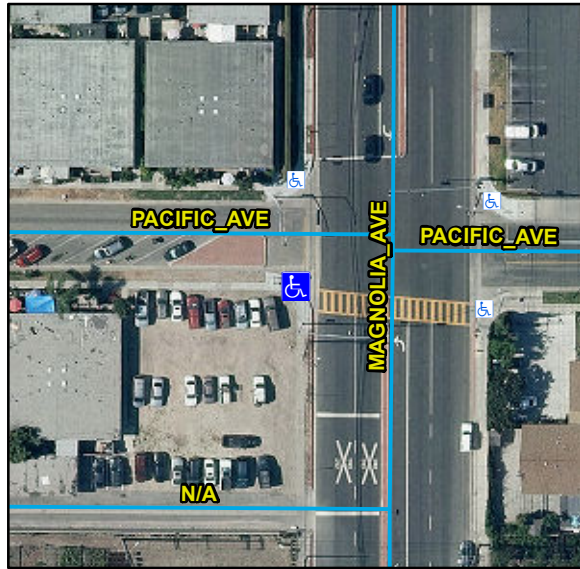
| Compliance | Description | Data | Compliance | Description | Data |
|---|---|---|---|---|---|
| No | Gutter Cross Slope (%) | 2.8 | | | |

Remove & Replace Landing. Remove & Replace Gutter.

R304.2.1, R304.5.3, STD 1115
