# Access Compliance Report Public Rights-of-Way (Curb Ramps)

Main Street: MAGNOLIA\_AVE Cross Street: PACIFIC\_AVE Location: NW

ADA ID: RPAT220202094723 Ramp Type: Type 1 - Perpendicular Initial Pass/Fail: Pass Overall Compliance: No Severity Score: 4

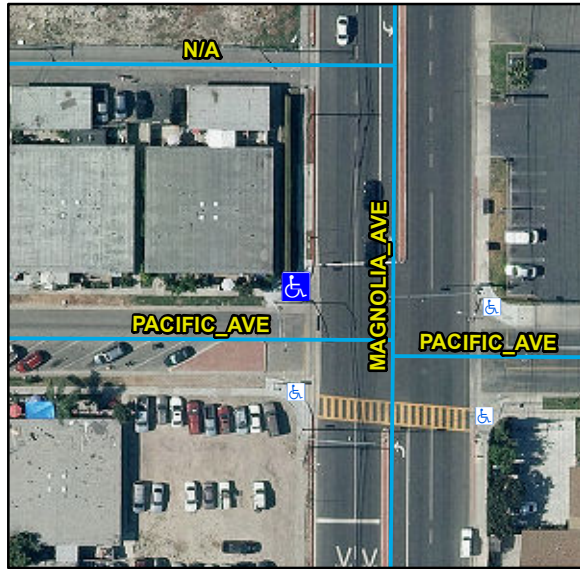
R304.2.1, R304.5.3, STD 1115

Possible Solutions:

Remove & Replace Landing. Remove & Replace Gutter.

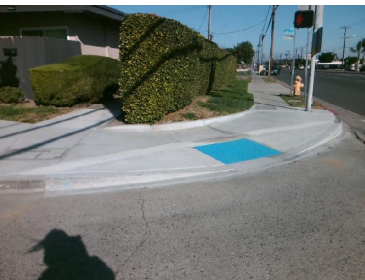
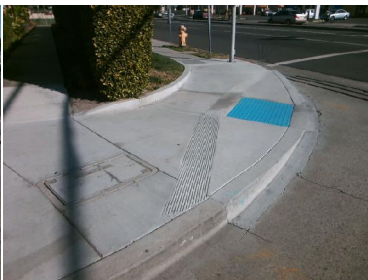
| Compliance | Description | Data | Compliance | Description | Data |
|---|---|---|---|---|---|
| No | Gutter Cross Slope (%) | 2.4 | | | |
| Yes | Overall Surface Condition: Acceptable | | Yes | Perp Joint Present | Yes |
