# Access Compliance Report Public Rights-of-Way (Curb Ramps)

Main Street: GARZA\_AVE Cross Street: N/A Location: NE

ADA ID: RPAT220202101537 Ramp Type: Type 4 - Parallel Initial Pass/Fail: Fail Overall Compliance: No Severity Score: 4

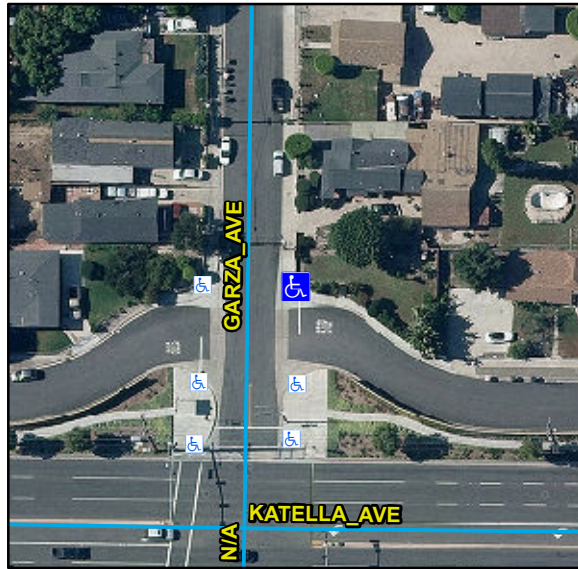
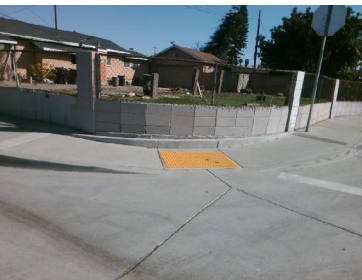
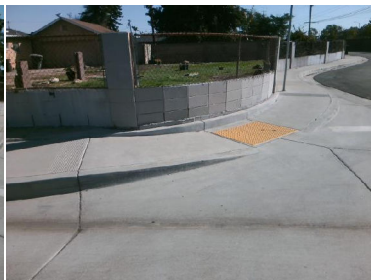
| Compliance | Description | Data | Compliance | Description | Data |
|---|---|---|---|---|---|
| No | Ramp Width LT (in) | 47 | No | Ramp Width RT (in) | 47 |
| Yes | Ramp Run Slope LT (%) | 7.24 | Yes | Ramp Run Slope RT (%) | 7.3 |

**Remove & Replace Curb Ramp With Two New Directional Ramps or Equivalent.**

**R304.5.1, STD 1115**

\$ 4000
