# Access Compliance Report Public Rights-of-Way (Curb Ramps)

Main Street: CRESTWOOD\_LN Cross Street: S\_BROOKHURST\_ST Location: NW

ADA ID: RPAT220202111306 Ramp Type: Type 1 - Perpendicular Initial Pass/Fail: Pass Overall Compliance: No Severity Score: 0

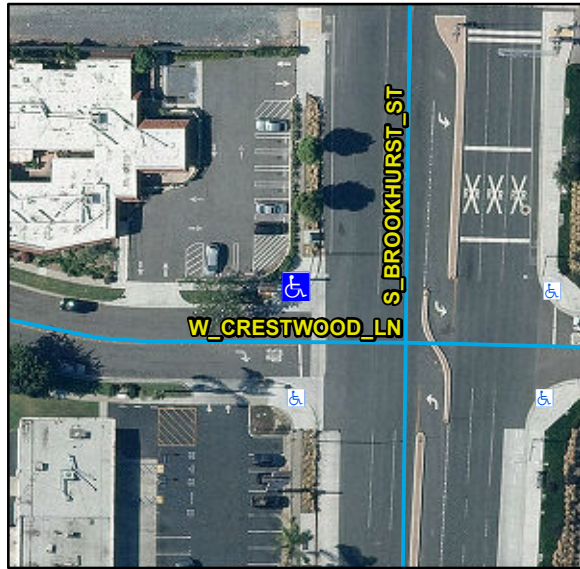
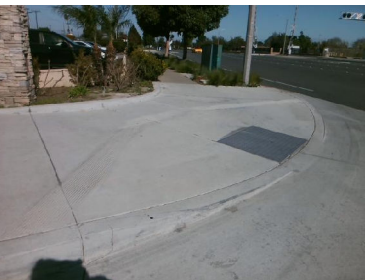
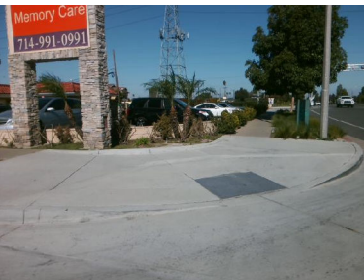
| Compliance | Description | Data | Compliance | Description | Data |
|---|---|---|---|---|---|
| N/A | Landing Movement Obstructed? | Yes | Yes | DWS Contrast | Yes |
| | Landing Movement Type | Curb | Yes | DWS Length (in) | 36 |

Remove & Replace Landing.

R304.2.1, STD 1115
