# Access Compliance Report Public Rights-of-Way (Curb Ramps)

Main Street: CRESTWOOD\_LN Cross Street: S\_BROOKHURST\_ST Location: SW

ADA ID: RPAT220202111848 Ramp Type: Type 1 - Perpendicular Initial Pass/Fail: Pass Overall Compliance: No Severity Score: 6

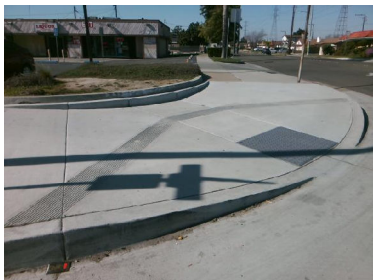
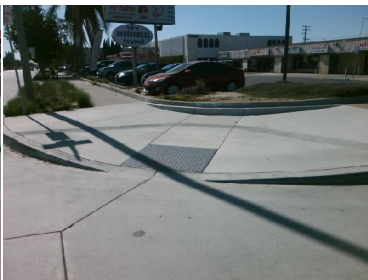
| Compliance | Description | Data | Compliance | Description | Data |
|---|---|---|---|---|---|
| No | Landing Run Slope (%) | 2.3 | N/A | Flare Traversable RT | Yes |
| Yes | Gutter Ponding | No | No | Curb Slope | 12.7 |
| No | Gutter Run Slope (%) | 6.6 | | Road Cross Slope (%) | N/A |

Remove & Replace Entire Ramp. Remove & Replace Gutter.
