# Access Compliance Report Public Rights-of-Way (Curb Ramps)

| Main Street: W_HARLE_AVE | | Cross Street: S_BROOKHURST_ST | | Location: | NE |
| ADA ID: RPAT220202140758 | Ramp Type:Type 1 - Perpendicular | Initial Pass/Fail: Pass | Overall Compliance: No | Severity Score: | 5 |

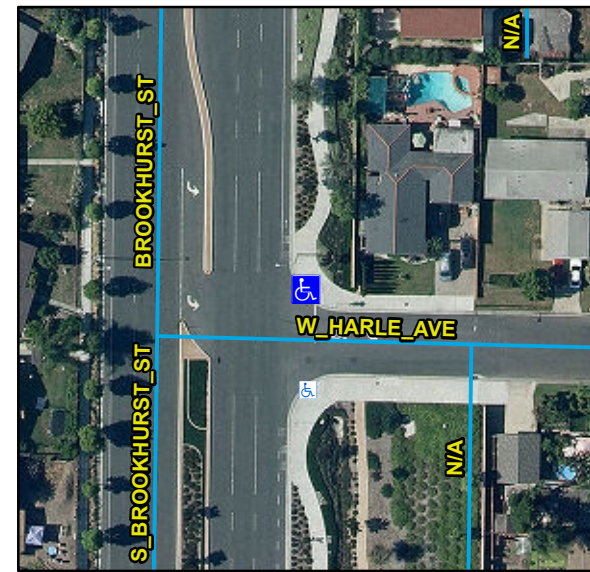
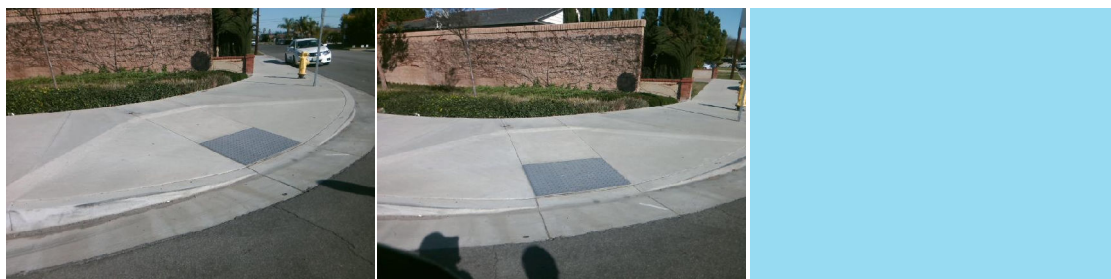
| Compliance | Description | Data | Compliance | Description | Data |
|---|---|---|---|---|---|
| Yes | Gutter Ponding | No | No | Curb Slope | 7.1 |
| No | Gutter Run Slope (%) | 5.1 | | Road Cross Slope (%) | N/A |

Possible Solutions:

Remove & Replace Curb Slope. Remove & Replace Gutter.

R304.2.2, R304.5.4, STD 1115

Total Cost: \$ 504
