# Access Compliance Report Public Rights-of-Way (Curb Ramps)

| Main Street: W_HARLE_AVE | | Cross Street: S_BROOKHURST_ST | | Location: | SE |
| ADA ID: RPAT220202141602 | Ramp Type:Type 1 - Perpendicular | Initial Pass/Fail: Pass | Overall Compliance: No | Severity Score: | 10 |

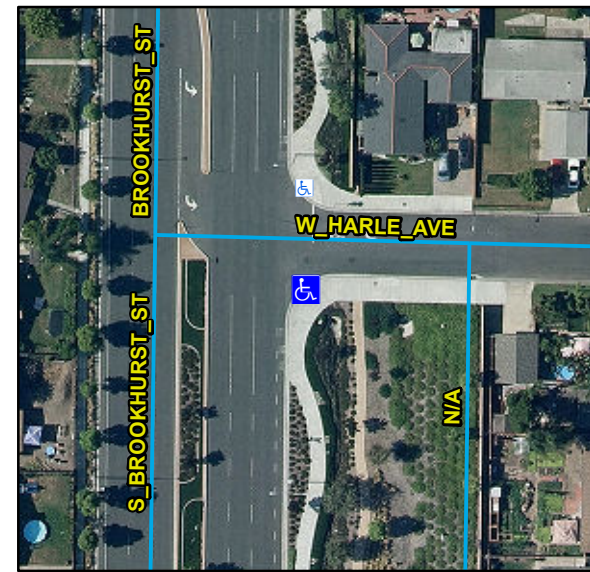
R304.2.2, R305.1.4, R304.5.4, R304.5.3, STD 1115

| Compliance | Description | Data | Compliance | Description | Data |
|---|---|---|---|---|---|
| N/A | Landing Shared | No | No | DWS Full Width | No |
| No | Gutter Run Slope (%) | 8.8 | | Road Cross Slope (%) | N/A |
| No | Gutter Cross Slope (%) | 2.1 | | | |

Possible Solutions:

Remove & Replace Entire Ramp. Remove & Replace Gutter.

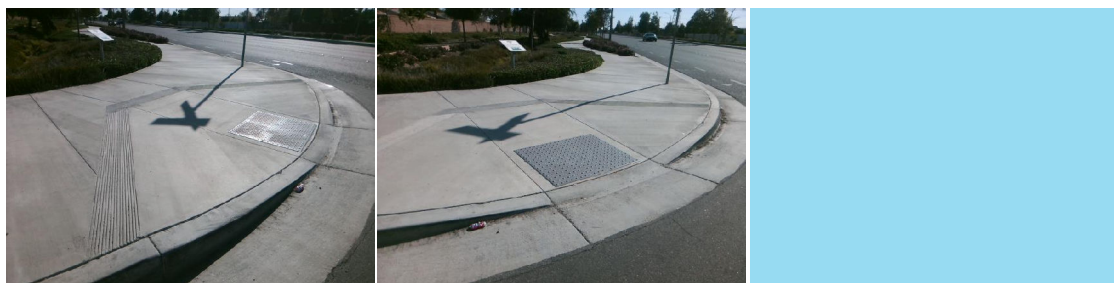
| Compliance | Description | Data | Compliance | Description | Data |
|---|---|---|---|---|---|
| N/A | Ramp Length (in) | 98 | N/A | Flare Type LT | |
| Yes | Ramp Width (in) | 59 | | | Sloped |
| Yes | Ramp Run Slope (%) | 7.6 | Yes | Flare Slope LT (%) | 6.9 |
| Yes | Ramp Cross Slope (%) | 0.8 | N/A | Flare Traversable LT | Yes |
| Yes | Gutter Ponding | No | No | Curb Slope | 6 |
