# Access Compliance Report Public Rights-of-Way (Curb Ramps)

Main Street: CERRITOS\_AVE Cross Street: BROOKHURST\_ST Location: NE

ADA ID: RPAT220202143245 Ramp Type: Type 1 - Perpendicular Diagonal Initial Pass/Fail: Pass Overall Compliance: No Severity Score: 0

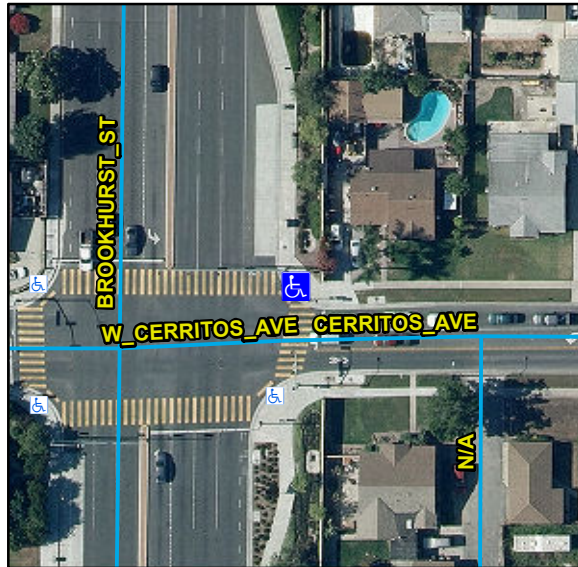
| Compliance | Description | Data | Compliance | Description | Data |
|---|---|---|---|---|---|
| Yes | Gutter Ponding | No | No | Curb Slope | 8.5 |

Possible Solutions:

Remove & Replace Curb Slope.

R304.2.2, STD 1115
