# Access Compliance Report Public Rights-of-Way (Curb Ramps)

| Main Street: W_HARRIET_LN | | Cross Street: BROOKHURST_ST | | Location: | NE |
| ADA ID: RPAT220202145313 | Ramp Type:Type 1 - Perpendicular | Initial Pass/Fail: Fail | Overall Compliance: No | Severity Score: | 4 |

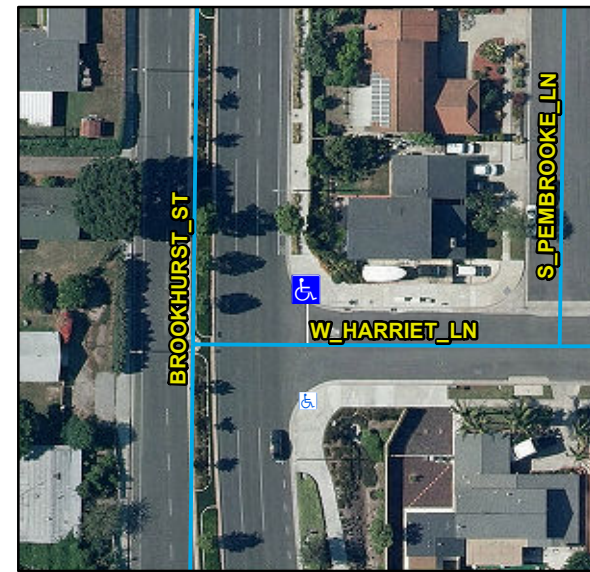
| Compliance | Description | Data | Compliance | Description | Data |
|---|---|---|---|---|---|
| No | Ramp Width (in) | 46 | | | N/A |
| N/A | Gutter Ponding | N/A | No | Curb Slope | 8.6 |

Remove & Replace Entire Ramp.

R304.2.2, R304.5.1, STD 1115
