# Access Compliance Report Public Rights-of-Way (Curb Ramps)

| Main Street: W_HARRIET_LN | | Cross Street: BROOKHURST_ST | | Location: | SE |
| ADA ID: RPAT220202145600 | Ramp Type:Type 1 - Perpendicular | Initial Pass/Fail: Fail | Overall Compliance: No | Severity Score: | 19 |

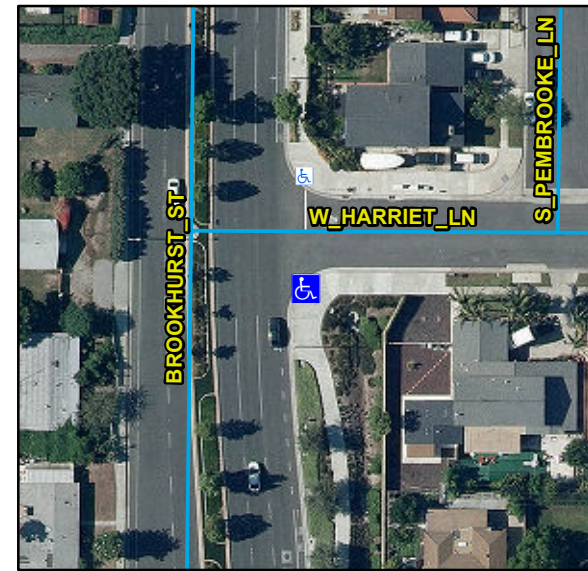
| Compliance | Description | Data | Compliance | Description | Data |
|---|---|---|---|---|---|
| No | Ramp Width (in) | 47 | | | N/A |
| No | Ramp Run Slope (%) | 8.7 | N/A | Flare Slope LT (%) | N/A |

Remove & Replace Entire Ramp.

R304.2.2, R304.5.1, STD 1115

Total Cost: \$ 3080
