# Access Compliance Report Public Rights-of-Way (Curb Ramps)

Main Street: PALAIS\_RD Cross Street: BROOKHURST\_ST Location: NE

ADA ID: RPAT220202150306 Ramp Type: Type 1 - Perpendicular Initial Pass/Fail: Fail Overall Compliance: No Severity Score: 4

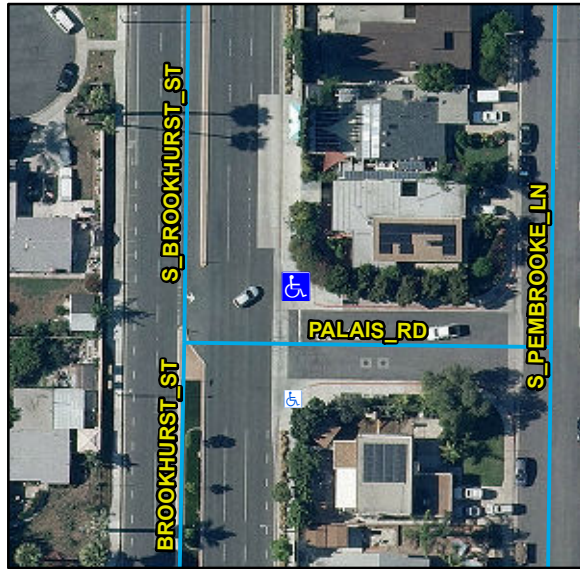
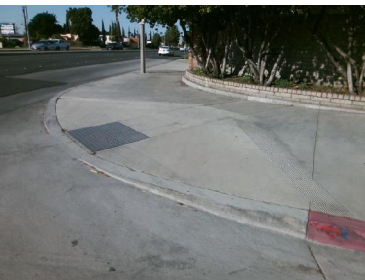
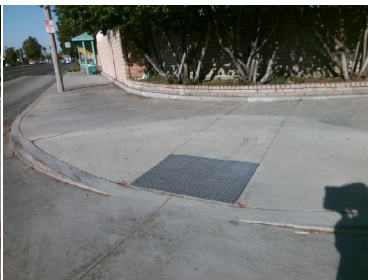
| Compliance | Description | Data | Compliance | Description | Data |
|---|---|---|---|---|---|
| No | Ramp Width (in) | 47 | | | N/A |
| N/A | Gutter Ponding | N/A | No | Curb Slope | 5.7 |

Remove & Replace Entire Ramp.

R304.2.2, R304.5.1, STD 1115

Total Cost: \$ 3080
