# Access Compliance Report Public Rights-of-Way (Curb Ramps)

Main Street: PALAIS\_RD Cross Street: BROOKHURST\_ST Location: SE

ADA ID: RPAT220202150553 Ramp Type: Type 1 - Perpendicular Initial Pass/Fail: Fail Overall Compliance: No Severity Score: 2

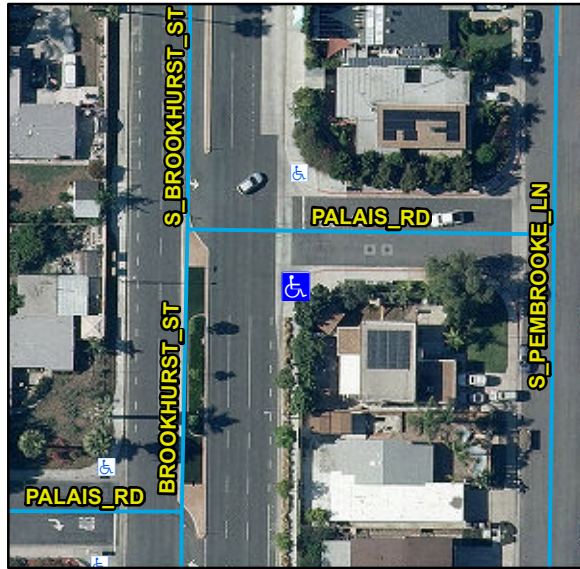
| Compliance | Description | Data | Compliance | Description | Data |
|---|---|---|---|---|---|
| No | Ramp Cross Slope (%) | 2.3 | N/A | Flare Traversable LT | N/A |
| N/A | Gutter Ponding | N/A | No | Curb Slope | 6.5 |

Remove & Replace Entire Ramp.

R304.2.2, R304.5.3, STD 1115
