# Access Compliance Report Public Rights-of-Way (Curb Ramps)

| Main Street: N/A | | Cross Street: S_GILBERT_ST | | Location: | NE |
| ADA ID: RPAT220202161017 | Ramp Type: Type 7 - Directional 2 | Initial Pass/Fail: Fail | Overall Compliance: No | Severity Score: | 0 |

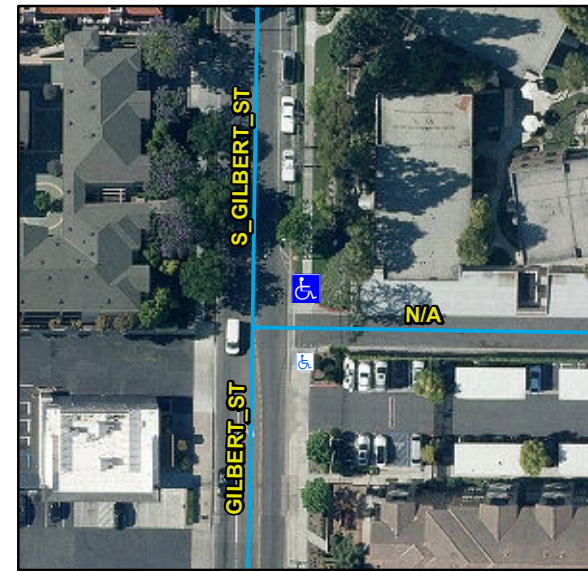
N/A

Possible Solutions:

Remove & Replace Entire Ramp.

STD 1115

\$ 3080

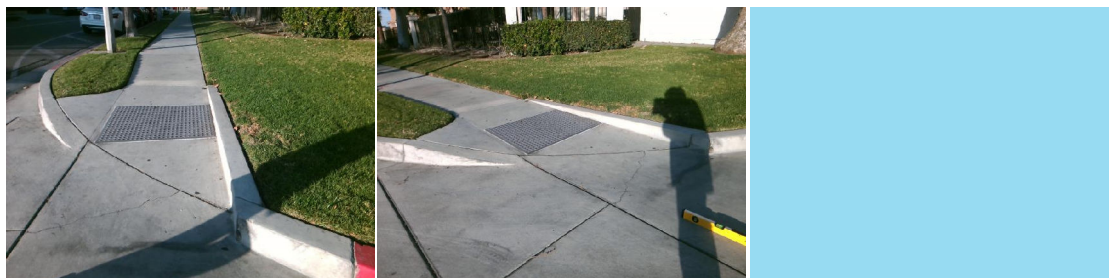
| Compliance | Description | Data | Compliance | Description | Data |
|---|---|---|---|---|---|
| N/A | Ramp Length (in) | 112 | N/A | Flare Type LT | |
| Yes | Ramp Width (in) | 48 | | | N/A |
| Yes | Ramp Run Slope (%) | 4.9 | N/A | Flare Slope LT (%) | N/A |
| Yes | Ramp Cross Slope (%) | 1.4 | N/A | Flare Traversable LT | N/A |
| N/A | Gutter Ponding | N/A | Yes | Curb Slope | 7 |
| Yes | Overall Surface Condition | Acceptable | Yes | Perp Joint Present | Yes |
