# Access Compliance Report Public Rights-of-Way (Curb Ramps)

Main Street: N/A Cross Street: S\_GILBERT\_ST Location: SE

ADA ID: RPAT220202161401 Ramp Type: Type 7 - Directional 2 Initial Pass/Fail: Fail Overall Compliance: No Severity Score: 0

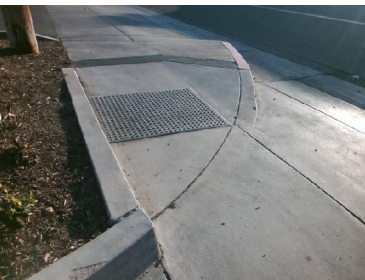
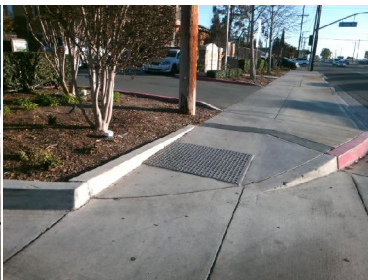
| Compliance | Description | Data | Compliance | Description | Data |
|---|---|---|---|---|---|
| Yes | Overall Surface Condition | Acceptable | Yes | Perp Joint Present | Yes |
