# Access Compliance Report Public Rights-of-Way (Curb Ramps)

Main Street: GILBERT\_ST Cross Street: STONYBROOK\_DR Location: NE

ADA ID: RPAT220202163836 Ramp Type: Type 4 - Parallel Initial Pass/Fail: Pass Overall Compliance: No Severity Score: 5

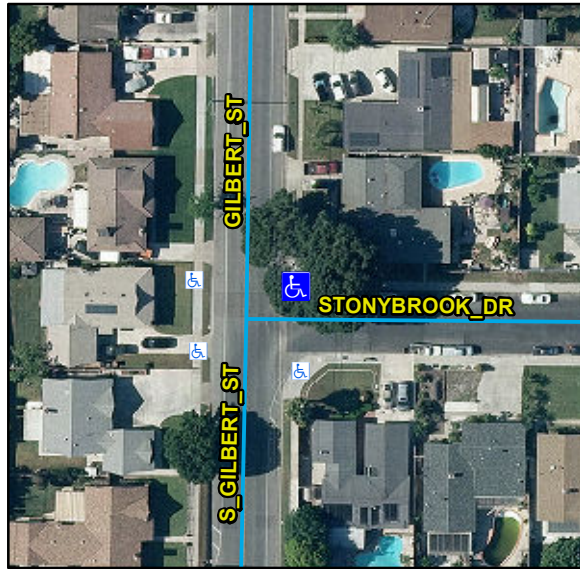
| Compliance | Description | Data | Compliance | Description | Data |
|---|---|---|---|---|---|
| No | Gutter Run Slope (%) | 6.1 | | Road Cross Slope (%) | N/A |

Remove & Replace Gutter.

R304.5.4, STD 1115

Total Cost: \$ 252
