# Access Compliance Report Public Rights-of-Way (Curb Ramps)

| Main Street: S_BROOKHURST_ST | | Cross Street: W_NIOBE_AVE | | Location: | NE |
| ADA ID: RPAT220202165045 | Ramp Type: Type 4 - Parallel | Initial Pass/Fail: Pass | Overall Compliance: Yes | Severity Score: | 0 |

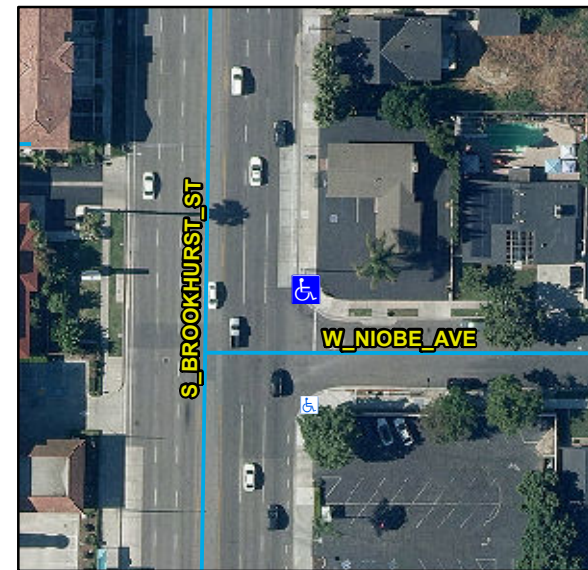
Surveyor Notes:

N/A

| Compliance | Description | Data | Compliance | Description | Data |
|---|---|---|---|---|---|
| Yes | Overall Surface Condition | Acceptable | | | |

Possible Solutions:

N/A
