# Access Compliance Report Public Rights-of-Way (Curb Ramps)

Main Street: W\_NIOBE\_AVE Cross Street: S\_BROOKHURST\_ST Location: SE

ADA ID: RPAT220202165609 Ramp Type: Type 4 - Parallel Initial Pass/Fail: Pass Overall Compliance: No Severity Score: 5

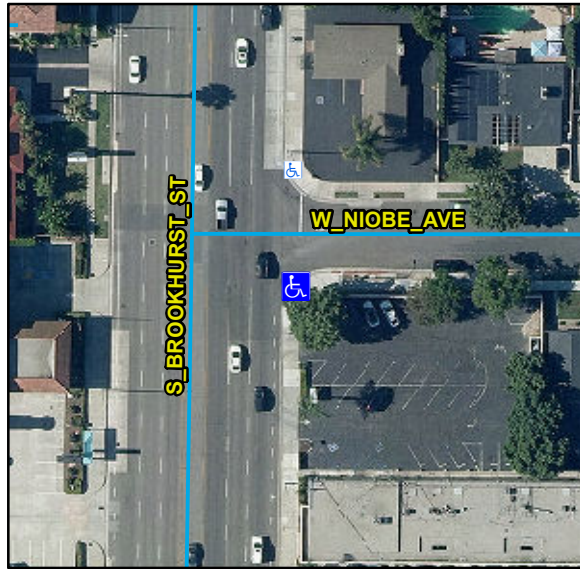
| Compliance | Description | Data | Compliance | Description | Data |
|---|---|---|---|---|---|
| No | Gutter Run Slope (%) | 7.3 | | Road Cross Slope (%) | N/A |

Possible Solutions:

Remove & Replace Gutter.

R304.5.4, STD 1115
